Technical review of mine closure plan and mine closure implementation at Minerales Entres Mares San Martin mine, Honduras

A report prepared for Caritas (Honduras) / CAFOD International by

**Dr Adam Jarvis and Dr Jaime Amezaga
(Newcastle University, UK)**

June 2009

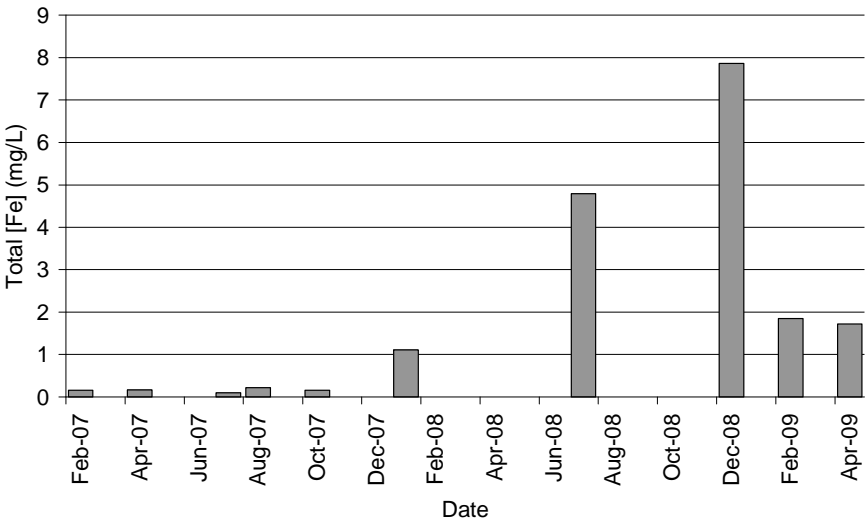
Figure 1. Concentrations of total iron at monitoring point M4 on the Quebrada Casitas. Data collected by DEFOMIN

- 1) Periodically elevated concentrations of iron in the Quebrada Casitas (at monitoring point M4), as illustrated in Figure 1 and, of more concern
- 2) A clear, and severe, incidence of AMD on 24 September 2008. The relevant data are shown in Table 1.

Iron is the contaminant most commonly associated with acid mine drainage, since it arises from the oxidative dissolution of the common mineral pyrite. The occasionally high concentrations of iron in the Quebrada Casitas may be related to AMD from the Tajo Palo Alto. However, this is not absolutely certain from the data available. Additional data would be required to confirm whether any future incidences of elevated iron concentrations were associated with discharges from the Tajo Palo Alto (and recommendations for appropriate sampling and analysis strategies are discussed later in this document).

In relation to water quality monitoring, it is recommended that additional sampling locations are monitored, and that the analytical suite is expanded. This recommendation applies as much to the activities of the regulatory authorities as the mine operator. Specifically, to properly assess any AMD arising from the Tajo Palo Alto and its impact on the Quebrada Casitas, it is recommended that:

- The discharge from the Tajo Palo Alto is monitored, as is the Quebrada Casitas upstream and downstream of the discharge point from the Tajo Palo Alto. Samples should be collected from all 3 locations on the same sampling trip to allow direct comparison of results.
